PHASE I MILESTONE INSPECTION

Ocean View Manor

3600 S Ocean View Manor

UES Project No: 0311.2400001.0024

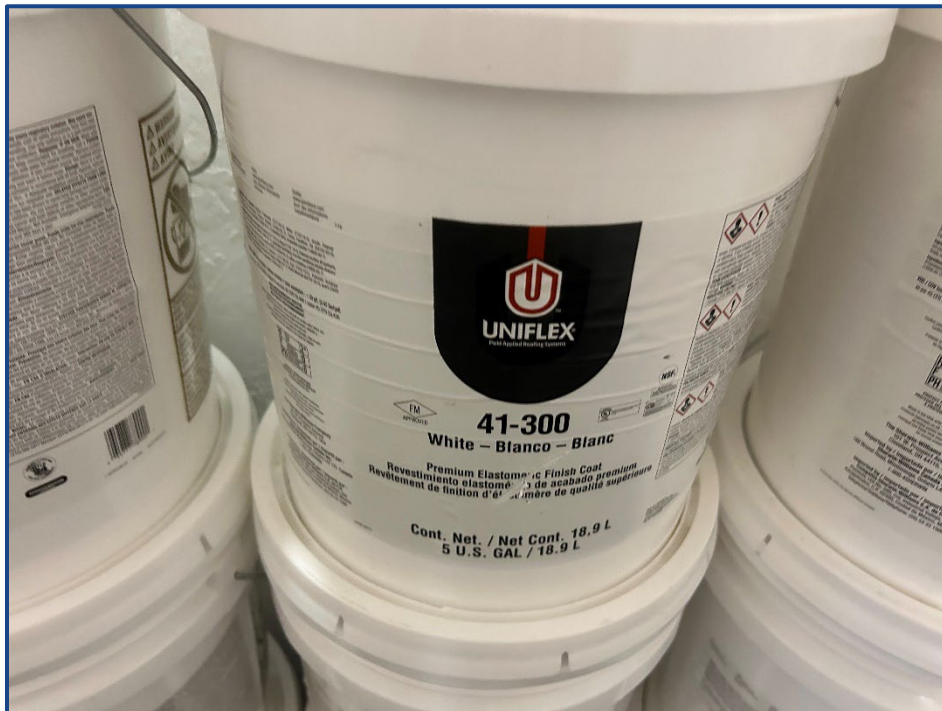
The building roof system has a flat roof. The built-up roof was recoated in November of 2024 with UNIFLEX 41-300 Premium White Elastomeric Roof Coating. The association replaces the coating on an annual basis. The roof has parapet walls and interior roof drains.

Photograph No. 16: White UNIFLEX coating being applied on the building roof.

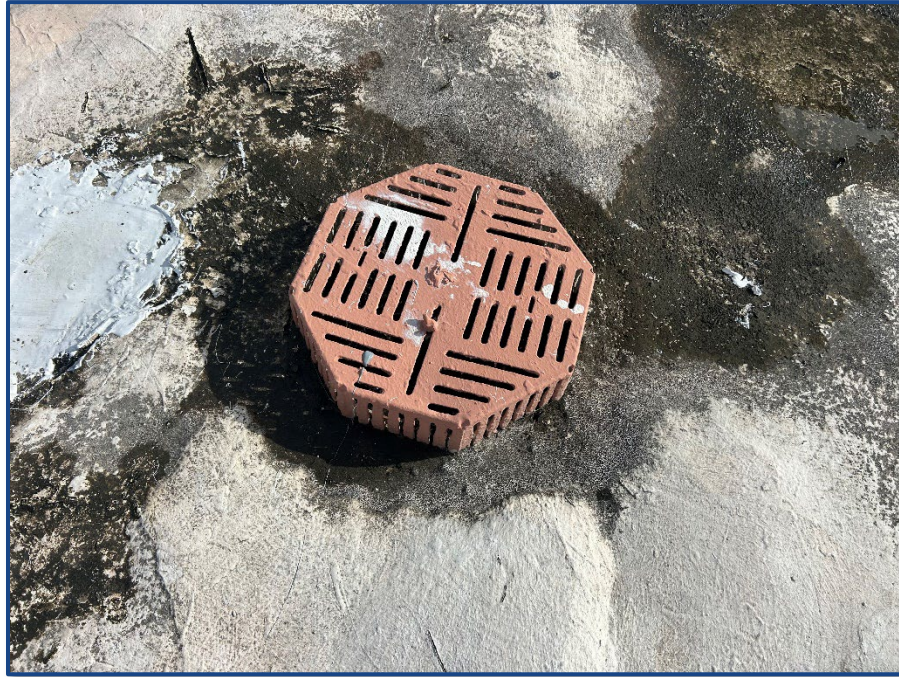
Photograph No. 17: Typical interior roof drain and cover in good overall condition.

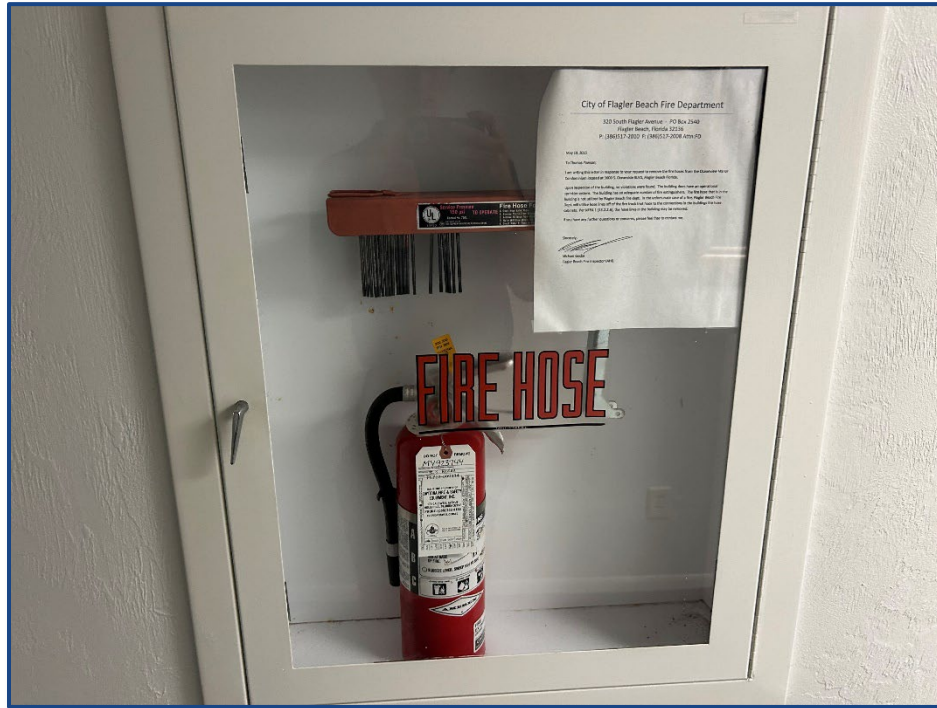
Photograph No. 31: Old fire hose access standpipe out of commission and fire extinguisher.

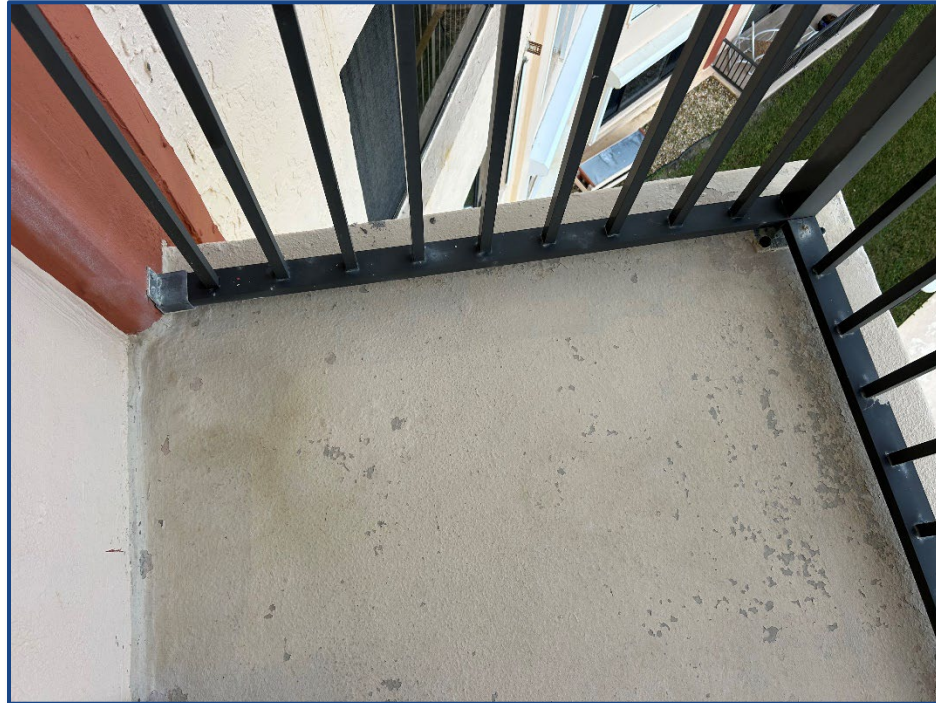
Photograph No. 46: Room 513 balcony with aluminum railings and some chipped paint.

- Painting walls and balcony decks on a regular basis to prevent rebar corrosion.

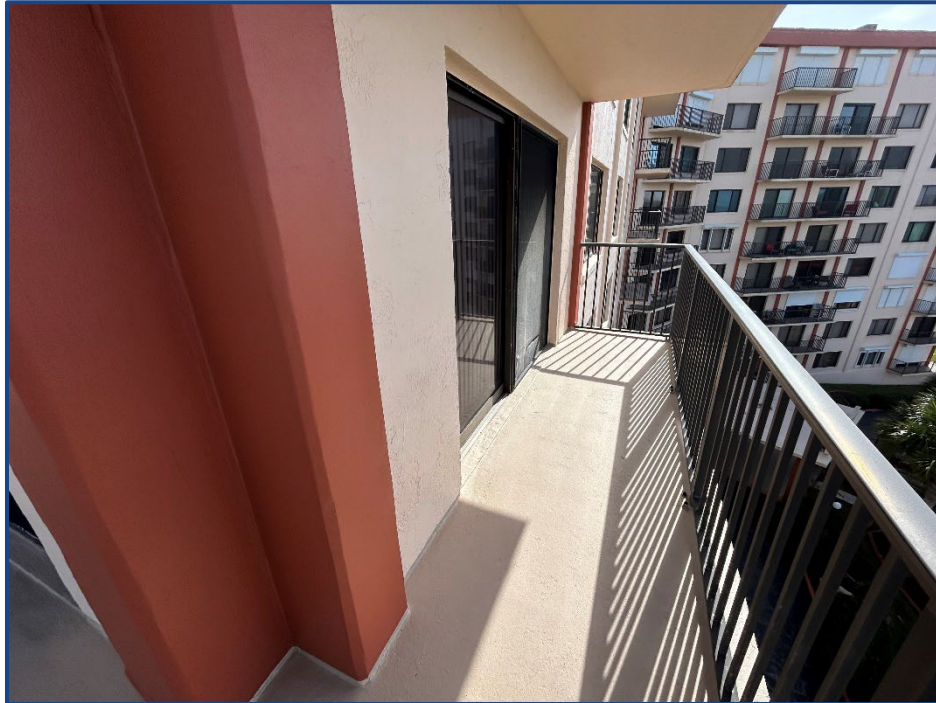
Photograph No. 48: Room 724 typical balcony area in good condition.

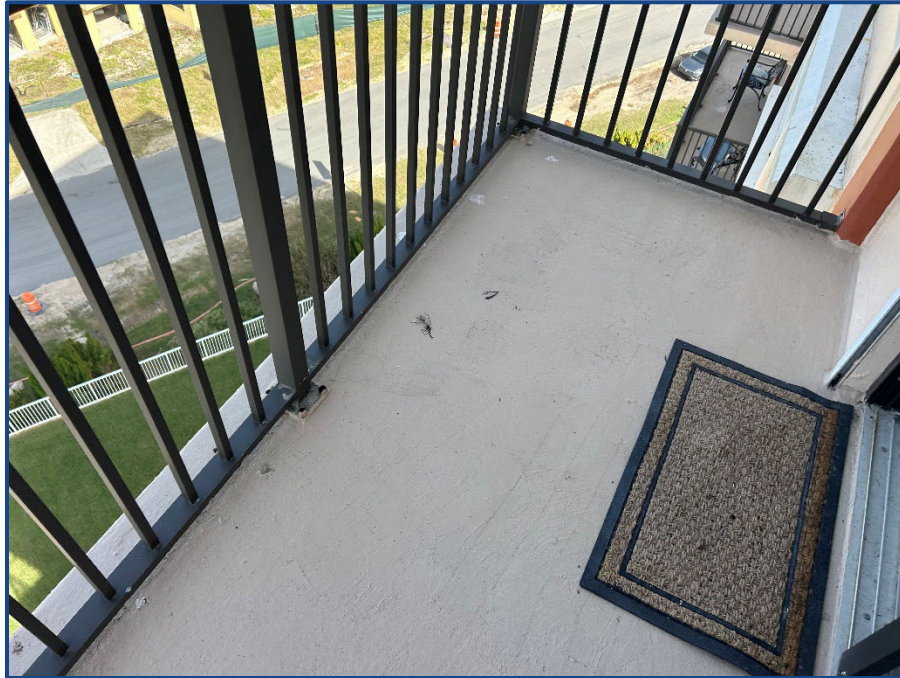
Photograph No. 50: Room 912 balcony area in good overall condition.
